AGING INFRASTRUCTURE HULL, MA MANHOLE REHABILITATION

AUTHOR: RAY BAHR, P.E.

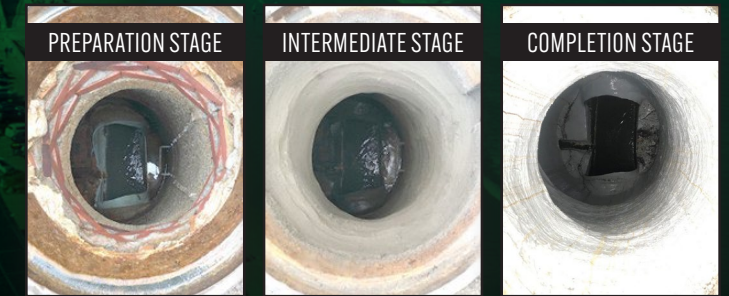
Preparation involved stopping infiltration, pressure washing the walls to a sound substrate, and addressing corrosion with exposed aggregate. The manhole, containing a CIPP liner, had its bench rebuilt to slope correctly. During the intermediate stage, leaks were sealed and patching completed with Strong-Seal® QSR. A ½ inch layer of Strong-Seal® High Performance Mix was applied, troweled smooth, and brushed to increase surface area for better epoxy adhesion.
